**Flood Control Project Maintenance
Levee Inspections****LMA District Cover Sheet
Spring 2016 Levee Inspection Results****Reclamation District No. 2104 Peters Pocket Tract**

Spring 2016 Levee Inspection Results

Reclamation District No. 2104 Peters Pocket Tract

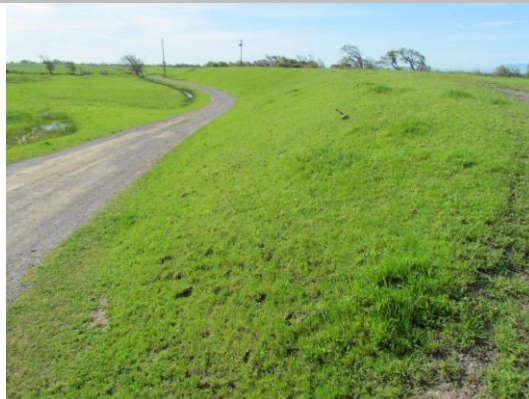
Photo 1 of 1 : SP_2016_RD2104_249_17_20160509_00043.jpg

LM Start	0.01	Rating **	A/W	Issue No.	17
LM End	0.88	Issue Type +	Ma	Location *	LS
Category	Earthen Levee			GPS Latitude/Longitude	
				Start	End
Item	Vegetation			38.308222 °	38.299307 °
				-121.758547 °	-121.749778 °
DWR ID	DWR_RD2104_01_s_2016_17				
Comment Code					
V1 : Control annual grass and weeds on the levee slopes and easements.					
Inspector Comment					
At this location there is no unwanted weeds present on the slope.

RD 2104 Looking downstream from levee mile 0.01 - 0.88.

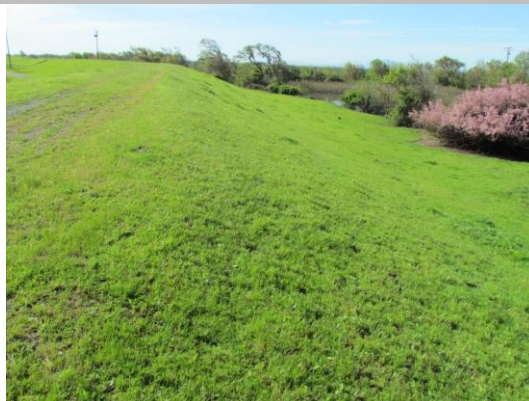
Photo 1 of 1 : SP_2016_RD2104_249_43_20160509_00042.jpg

LM Start	0.04	Rating **	A/W	Issue No.	43
LM End	0.42	Issue Type +	Ma	Location *	WS
Category	Earthen Levee			GPS Latitude/Longitude	
				Start	End
Item	Vegetation			38.307713 °	38.302670 °
				-121.758527 °	-121.756470 °
DWR ID	DWR_RD2104_01_f_2015_43				
Comment Code					
V1 : Control annual grass and weeds on the levee slopes and easements.					
Inspector Comment

RD 2104 Waterside slope from levee mile 0.04- 0.42.

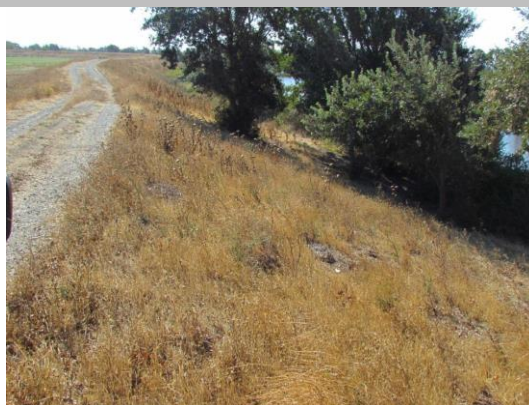
Photo 1 of 1 : SP_2016_RD2104_249_51_20160223_00005.jpg

Looking downstream waterside 0.42-0.68 unsatisfactory tall weeds covering the slope.

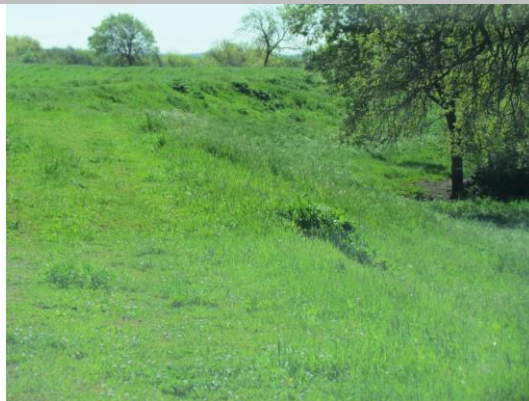
Photo 1 of 1 : SP_2016_RD2104_249_62_20160516_00055.jpg

RD 2104 Looking downstream from levee mile 0.89- 1.48 tall weeds present on the waterside slope.

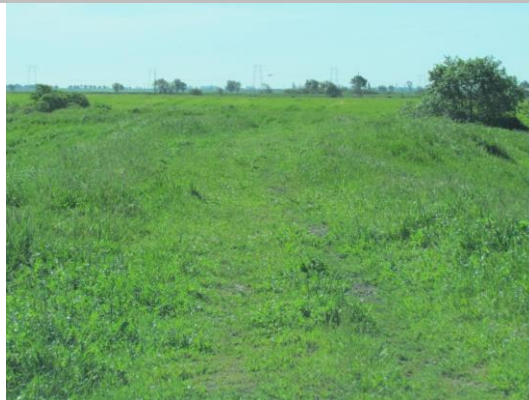
Photo 1 of 1 : SP_2016_RD2104_249_27_20160509_00044.jpg

LM Start	1.00	Rating **	U	Issue No.	27
LM End	4.74	Issue Type +	Ma	Location *	CR
Category	Earthen Levee			GPS Latitude/Longitude	
				Start	End
Item	Vegetation			38.298230 °	38.318552 °
				-121.748317 °	-121.744915 °
DWR ID	DWR_RD2104_01_s_2016_27				
Comment Code					
V9 : Keep the crown roadway free of vegetation.					
Inspector Comment					
The crown roadway should be free of vegetation.

RD 2104 Levee miles 1.00- 4.74 looking downstream crown roadway.

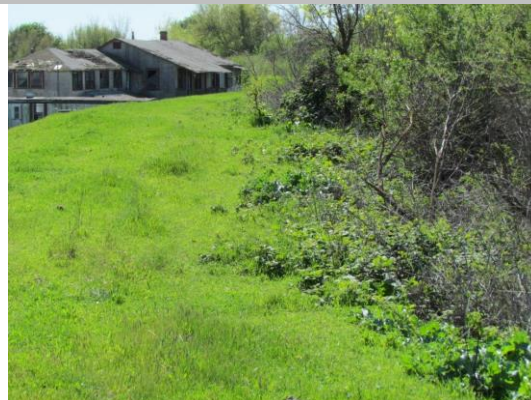
Photo 1 of 1 : SP_2016_RD2104_249_49_20160509_00045.jpg

RD 2104 Looking downstream from levee miles 1.38-1.48 woody tree growth on the shoulder and completely blocking the slope.

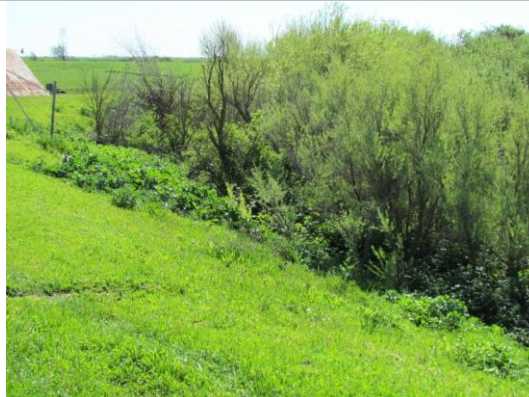
Photo 1 of 1 : SP_2016_RD2104_249_32_20160517_00057.jpg

RD 2104 Looking at the wild growth of willow trees, wild berries and other unwanted vegetation has established it self along the slope and toe to levee mile 4.74.

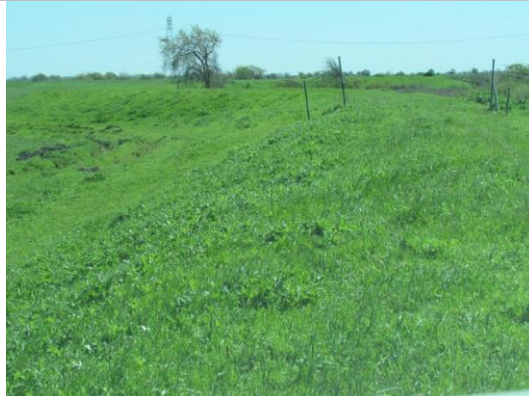
Photo 1 of 1 : SP_2016_RD2104_249_34_20160516_00054.jpg

LM Start	1.61	Rating **	U	Issue No.	34
LM End	5.75	Issue Type +	Ma	Location *	LS
Category	Earthen Levee			GPS Latitude/Longitude	
				Start	End
Item	Vegetation			38.293948 °	38.324073 °
				-121.739630 °	-121.758200 °
DWR ID	DWR_RD2104_01_s _ 2016_34				
Comment Code					
V1 : Control annual grass and weeds on the levee slopes and easements.					
Inspector Comment					
Mow or spray the landside slope from 1.61 to 5.75 of unwanted tall weeds. No maintenance has been done to the landside slope for sometime now.

RD 2104 Looking downstream from levee mile 1.61 to 5.75 the landside slopes is covered with unwanted tall weeds.

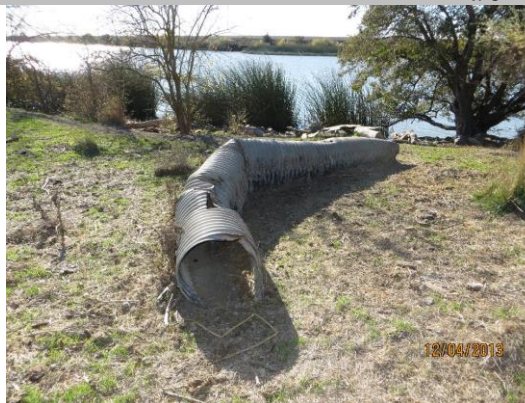
Photo 1 of 1 : UCIP_SP_2016_41347_45043.jpg

LM Start	2.40	Rating **	M	Issue No.	128
LM End	2.40	Issue Type +	En	Location *	CR
Category	Supplemental			GPS Latitude/Longitude	
				Start	End
Item	DWR UCIP Field Study			38.291579 °	38.291579 °
				-121.726159 °	-121.726159 °
DWR ID					
Comment Code					
Inspector Comment					
FS_ID:41347					
DS_ID:24726					
EP_NO: N/A					
Repair Type: Non-Urgent					
Crossing Status: Indicator Found					
UCIP Comments: 24-inch CMP debris on WS berm may indicate pipe was abandoned.					
FIELD_STRUCT_DESC: 24-inch CMP drain pipe through the levee 18-feet below the crown. Flapgate on the WS toe. Originally included in O+M manual, 1964.					
FS Date: 12/4/2013

Pipe debris on WS berm.

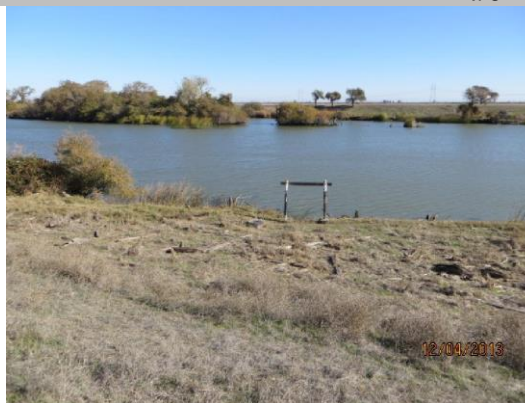
Photo 1 of 2 : UCIP_SP_2016_41834_45069.jpg

LM Start	3.04	Rating **	M	Issue No.	129
LM End	3.04	Issue Type +	En	Location *	CR
Category	Supplemental			GPS Latitude/Longitude	
				Start	End
Item	DWR UCIP Field Study			38.299447 °	38.299447 °
				-121.730444 °	-121.730444 °
DWR ID					
Comment Code					
Inspector Comment					
FS_ID:41834 DS_ID:24720 EP_NO: 14184 Repair Type: Non-Urgent Crossing Status: Found UCIP Comments: Signs in disrepair and need proper markings. FIELD_STRUCT_DESC: 6-inch steel gasoline through the levee 3-feet below the crown. Signs on LS and WS toe. FS Date: 12/4/2013

Sign on WS berm.

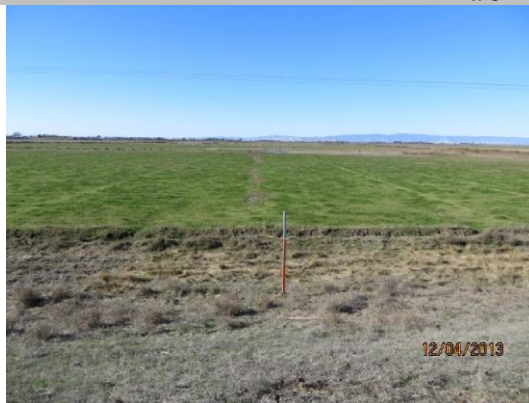
Photo 2 of 2 : UCIP_SP_2016_41834_45068.jpg

LM Start	3.04	Rating **	M	Issue No.	129 (cont)	
LM End	3.04	Issue Type +	En	Location *	CR	
Category	Supplemental			GPS Latitude/Longitude		
				Start		End
Item	DWR UCIP Field Study			38.299447 °		38.299447 °
				-121.730444 °		-121.730444 °
DWR ID						
Comment Code						
Inspector Comment						
FS_ID:41834						
DS_ID:24720						
EP_NO: 14184						
Repair Type: Non-Urgent						
Crossing Status: Found						
UCIP Comments: Signs in disrepair and need proper markings.						
FIELD_STRUCT_DESC: 6-inch steel gasoline through the levee 3-feet below the crown. Signs on LS and WS toe.						
FS Date: 12/4/2013

Sign post on LS toe.

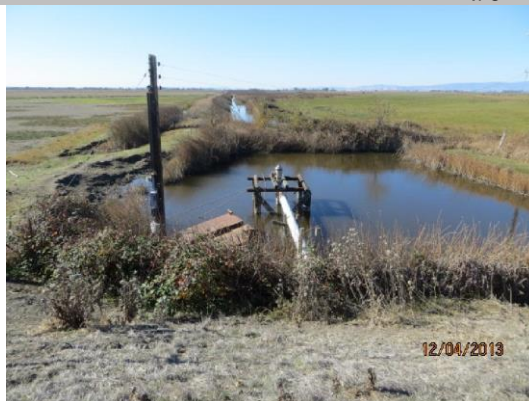
Photo 1 of 2 : UCIP_SP_2016_24995_45056.jpg

LM Start	4.01	Rating **	U	Issue No.	120
LM End	4.01	Issue Type +	En	Location *	CR
Category	Supplemental			GPS Latitude/Longitude	
				Start	End
Item	DWR UCIP Field Study			38.310873 °	38.310873 °
				-121.736189 °	-121.736189 °
DWR ID					
Comment Code					
Inspector Comment					
FS_ID:24995 DS_ID:24706 EP_NO: 10183 Repair Type: Urgent Crossing Status: Found UCIP Comments: Pipe rusted through on WS berm. Siphon breaker in CMP riser blocked by riser misalignment. FIELD_STRUCT_DESC: 12-inch steel drainpipe through the levee 4.0-feet below the crown. Pump on pile structure in drainage ditch on landward side. One C.M. cutoff wall and a Siphon breaker in a 24-inch CMP riser on the waterward shoulder. Flap gate on waterward end. (ABO No. 10183 - Miller) Originally included in O+M manual, 1964. Asbuilt Dwg. 50-04-3379. FS Date: 12/4/2013

Pump on pier off LS toe at ponding area. power pole and meter on LS toe.

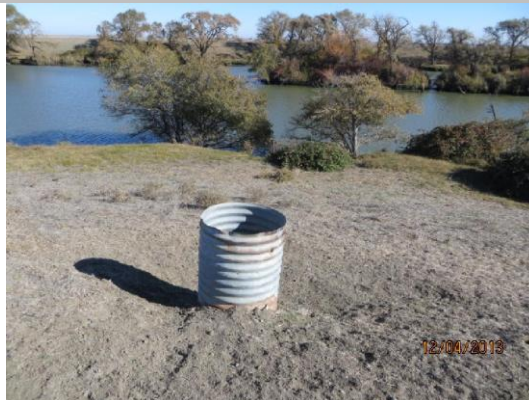
Photo 2 of 2 : UCIP_SP_2016_24995_45055.jpg

LM Start	4.01	Rating **	U	Issue No.	120 (cont)
LM End	4.01	Issue Type +	En	Location *	CR

Siphon breaker in CMP riser on WS slope.

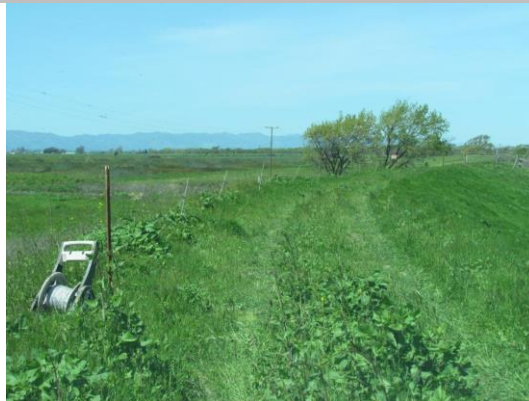
Photo 1 of 2 : SP_2016_RD2104_249_50_20160509_00050.jpg

Levee mile 4.15 -4.21 landside shoulder unauthorized electric fence on levee.

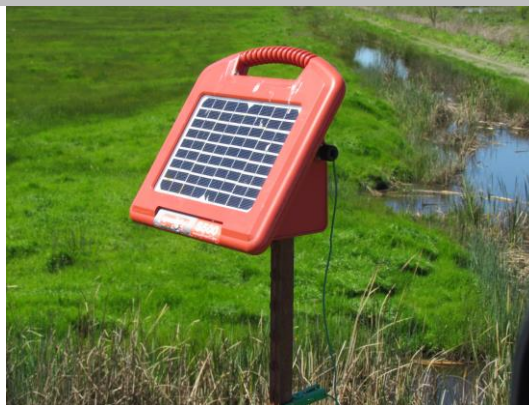
Photo 2 of 2 : SP_2016_RD2104_249_50_20160509_00051.jpg

LM Start	4.15	Rating **	U	Issue No.	50 (cont)
LM End	4.21	Issue Type +	En	Location *	LS

Solar panel for electric fence at levee mile 4.21.

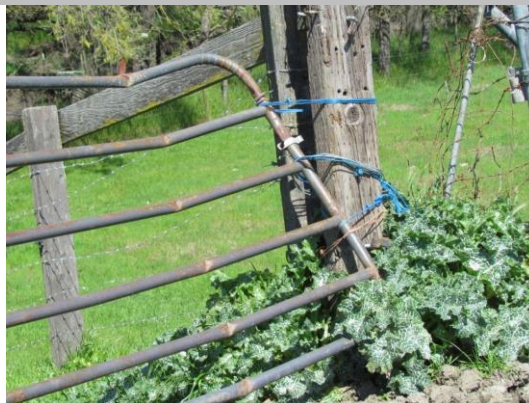
Photo 1 of 1 : SP_2016_RD2104_249_52_20160509_00052.jpg

LM Start	4.23	Rating **	U	Issue No.	52
LM End	4.23	Issue Type +	Ma	Location *	CR
Category	Earthen Levee			GPS Latitude/Longitude	
				Start	End
Item	Repair Gates			38.313075 °	38.313075 °
				-121.738990 °	-121.738990 °
DWR ID	DWR_RD2104_01_s _ 2016_52				
Comment Code					
Inspector Comment					
Replace this busted gate crossing the crown roadway. This gate poses a safety issue.

Levee mile 4.23 busted unsafe gate crossing crown roadway.

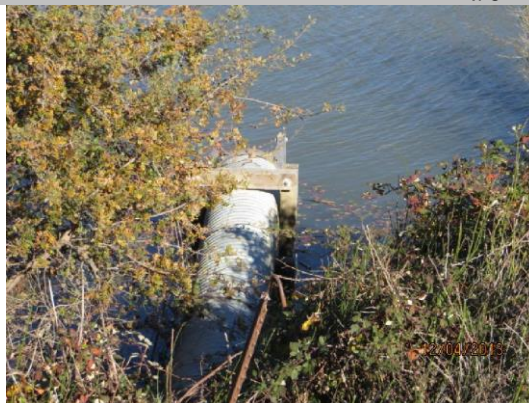
Photo 1 of 2 : UCIP_SP_2016_24996_45062.jpg

LM Start	4.31	Rating **	U	Issue No.	121
LM End	4.31	Issue Type +	En	Location *	CR
Category	Supplemental			GPS Latitude/Longitude	
				Start	End
Item	DWR UCIP Field Study			38.313955 °	38.313955 °
				-121.739930 °	-121.739930 °
DWR ID					
Comment Code					
Inspector Comment					
FS_ID:24996 DS_ID:24705 EP_NO: 10182 Repair Type: Urgent Crossing Status: Found UCIP Comments: Vegetation and soil buildup throughout pipe preventing flapgate from closing. Remove vegetation to allow gate to close properly. FIELD_STRUCT_DESC: 24-inch CMP drainpipe through the levee 15.0-feet below the crown. 36-inch concrete standpipe on LS toe. Flapgate on WS toe. Two C.M. cut of walls. (ABO No. 10182 - Machado) Originally included in O+M manual, 1964. Asbuilt Dwg. 50-04-3379. FS Date: 12/4/2013

CMP pipe and flapgate off WS toe.

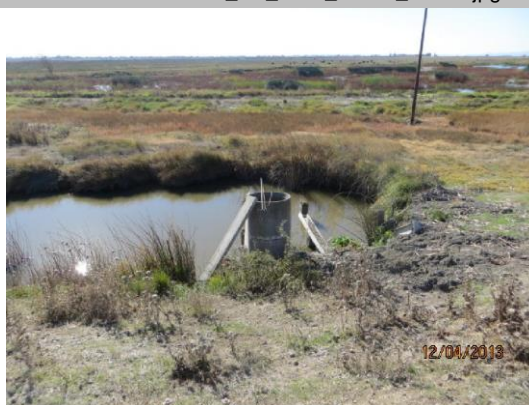
Photo 2 of 2 : UCIP_SP_2016_24996_45061.jpg

LM Start	4.31	Rating **	U	Issue No.	121 (cont)
LM End	4.31	Issue Type +	En	Location *	CR

36-inch concrete riser on LS toe at channel.

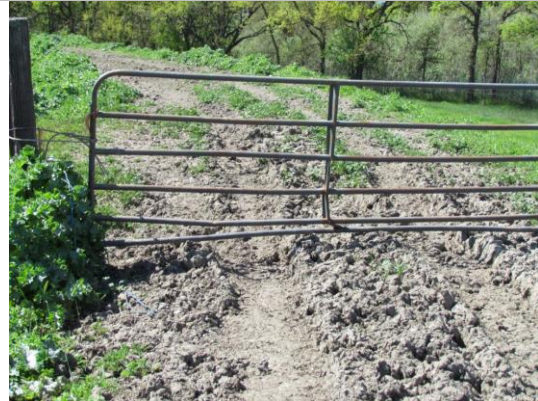
Photo 1 of 1 : SP_2016_RD2104_249_58_20160519_00063.jpg

LM Start	4.66	Rating **	U	Issue No.	58
LM End	6.15	Issue Type +	Ma	Location *	CR
Category	Earthen Levee			GPS Latitude/Longitude	
				Start	End
Item	Crown Surface / Depressions / Rutting			38.318058 °	38.318320 °
				-121.743600 °	-121.758217 °
DWR ID	DWR_RD2104_01_s_2016_58				
Comment Code					
C2 : Repair depressions or ruts in the crown or slope.					
Inspector Comment					
Crown roadway completely damaged by livestock, need appropriate material added and regraded. This levee crown need to have more road base and gravel through the District.

RD 2104 Looking downstream from levee mile 4.66 to levee mile 6.15 it appears that the cattle was corralled on the crown during the rainy months.

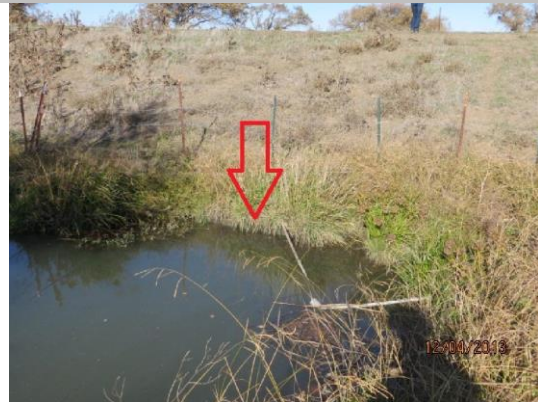
Photo 1 of 2 : UCIP_SP_2016_25005_45083.jpg

LM Start	4.67	Rating **	M	Issue No.	123
LM End	4.67	Issue Type +	En	Location *	CR
Category	Supplemental			GPS Latitude/Longitude	
				Start	End
Item	DWR UCIP Field Study			38.318119 °	38.318119 °
				-121.743730 °	-121.743730 °
DWR ID					
Comment Code					
Inspector Comment					
FS_ID:25005 DS_ID:24703 EP_NO: N/A Repair Type: Non-Urgent Crossing Status: Found UCIP Comments: Good candidate for video inspection. FIELD_STRUCT_DESC: 18-inch steel irrigation pipe through the levee 13.5-feet below the crown. Pump on pile structure in stream. Slide gate in 36-inch CMP riser on waterward slope. Two cutoff walls. Concrete "U" headwall and air vent at toe of landward slope. Asbuilt Dwg. 50-04-3379. Electrical conduit through levee at same location. FS Date: 12/4/2013

Concrete headwall on LS toe at irrigation ditch.

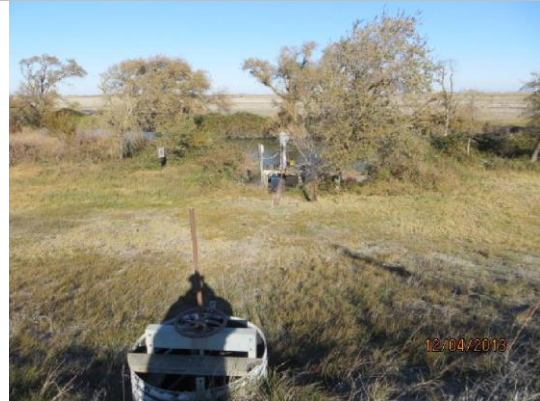
Photo 2 of 2 : UCIP_SP_2016_25005_45082.jpg

LM Start	4.67	Rating **	M	Issue No.	123 (cont)
LM End	4.67	Issue Type +	En	Location *	CR
Category	Supplemental			GPS Latitude/Longitude	
				Start	End
Item	DWR UCIP Field Study			38.318119 °	38.318119 °
				-121.743730 °	-121.743730 °
DWR ID					
Comment Code					
Inspector Comment					
FS_ID:25005					
DS_ID:24703					
EP_NO: N/A					
Repair Type: Non-Urgent					
Crossing Status: Found					
UCIP Comments: Good candidate for video inspection.					
FIELD_STRUCT_DESC: 18-inch steel irrigation pipe through the levee					
13.5-feet below the crown. Pump on pile structure in stream. Slide gate					
in 36-inch CMP riser on waterward slope. Two cutoff walls. Concrete					
"U" headwall and air vent at toe of landward slope. Asbuilt Dwg. 50-04-					
3379. Electrical conduit through levee at same location.					
FS Date: 12/4/2013

Slide gate in CMP riser on WS slope with pump on pier in background.

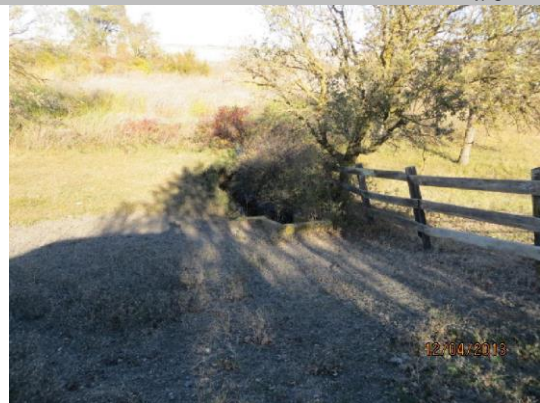
Photo 1 of 2 : UCIP_SP_2016_25006_45086.jpg

LM Start	4.72	Rating **	M	Issue No.	124
LM End	4.72	Issue Type +	En	Location *	CR
Category	Supplemental			GPS Latitude/Longitude	
				Start	End
Item	DWR UCIP Field Study			38.318432 °	38.318432 °
				-121.744540 °	-121.744540 °
DWR ID					
Comment Code					
Inspector Comment					
FS_ID:25006 DS_ID:24702 EP_NO: 10182 Repair Type: Non-Urgent Crossing Status: Found UCIP Comments: Minor erosion of base under headwall on WS toe. Heavy corrosion of pipe at WS toe. Further evaluation of pipe integrity needed. FIELD_STRUCT_DESC: 24-inch CMP drain pipe through the levee 13.5-feet below the crown. Concrete "U" headwalls on both ends. Two C.M. cutoff walls. Flap gate on waterward end. (ABO No. 10182 - Machado) FS Date: 12/4/2013

Concrete U shaped headwall on WS toe.

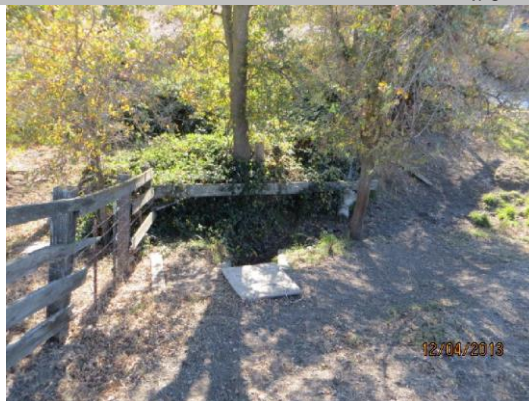
Photo 2 of 2 : UCIP_SP_2016_25006_45085.jpg

LM Start	4.72	Rating **	M	Issue No.	124 (cont)
LM End	4.72	Issue Type +	En	Location *	CR
Category	Supplemental			GPS Latitude/Longitude	
				Start	End
Item	DWR UCIP Field Study			38.318432 °	38.318432 °
				-121.744540 °	-121.744540 °
DWR ID					
Comment Code					
Inspector Comment					
FS_ID:25006 DS_ID:24702 EP_NO: 10182 Repair Type: Non-Urgent Crossing Status: Found UCIP Comments: Minor erosion of base under headwall on WS toe. Heavy corrosion of pipe at WS toe. Further evaluation of pipe integrity needed. FIELD_STRUCT_DESC: 24-inch CMP drain pipe through the levee 13.5-feet below the crown. Concrete "U" headwalls on both ends. Two C.M. cutoff walls. Flap gate on waterward end. (ABO No. 10182 - Machado) FS Date: 12/4/2013

Concrete U shaped headwall on LS toe.

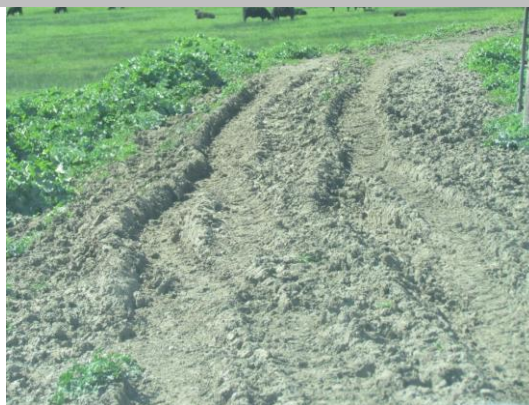
Photo 1 of 2 : SP_2016_RD2104_249_54_20160509_00048.jpg

RD 2104 Levee mile 4.90- 6.83 severely damaged crown roadway looking upstream.

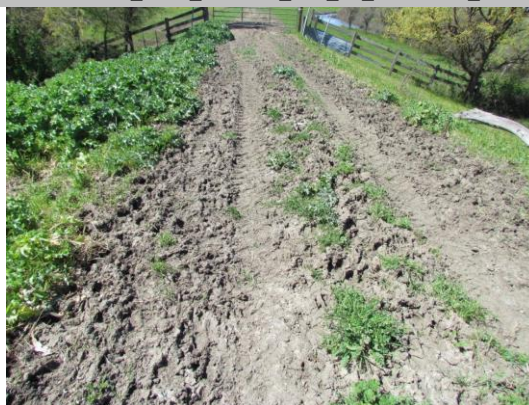
Photo 2 of 2 : SP_2016_RD2104_249_54_20160509_00049.jpg

LM Start	4.90	Rating **	M	Issue No.	54 (cont)
LM End	6.83	Issue Type +	Ma	Location *	CR

Another view of the damaged crown roadway looking downstream.

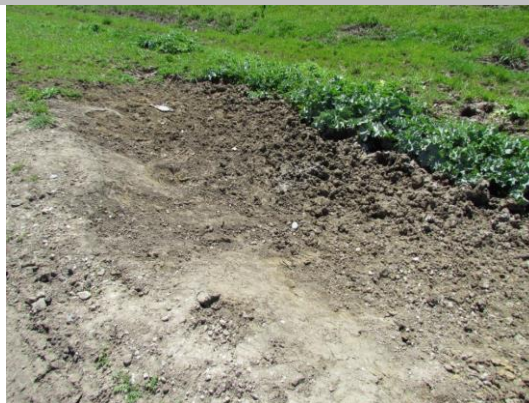
Photo 1 of 1 : SP_2016_RD2104_249_75_20160517_00060.jpg

LM Start	4.96	Rating **	U	Issue No.	75
LM End	4.96	Issue Type +	Ma	Location *	LS
Category	Earthen Levee			GPS Latitude/Longitude	
				Start	End
Item	Erosion / Bank Caving			38.320408 °	38.320408 °
				-121.748173 °	-121.748173 °
DWR ID	DWR_RD2104_01_f_2015_75				
Comment Code					
E2 : Schedule repair of erosion site prior to the next inspection.					
Inspector Comment					
Repair the erosion on the landside slope caused by livestock.

Erosion site on the landside shoulder and slope. Looking back upstream. No change since last inspection Fall 2016.

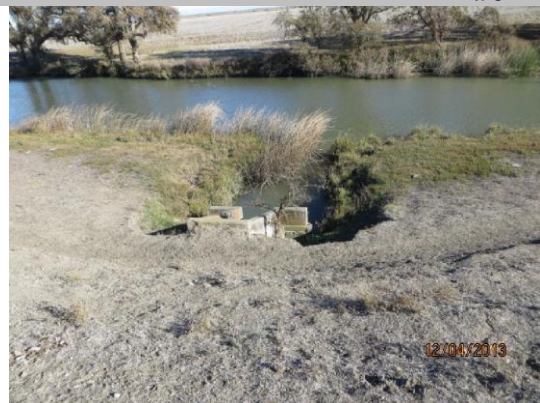
Photo 1 of 2 : UCIP_SP_2016_25007_45090.jpg

LM Start	5.09	Rating **	U	Issue No.	125
LM End	5.09	Issue Type +	En	Location *	LS
Category	Supplemental			GPS Latitude/Longitude	
				Start	End
Item	DWR UCIP Field Study			38.322215 °	38.322215 °
				-121.748418 °	-121.748418 °
DWR ID					
Comment Code					
Inspector Comment					
FS_ID:25007 DS_ID:24701 EP_NO: 10182 Repair Type: Urgent Crossing Status: Found UCIP Comments: Footing under headwall on WS toe severely undermined. Pipe rusted heavily with holes at WS and may need replacement. FIELD_STRUCT_DESC: 24-inch CMP drain pipe through levee 13.0 feet below crown. Two cutoff walls. Concrete "U" headwalls on both ends. Flap gate on water end. (ABO No. 10182 - Machado). Asbuilt Dwg. 50-04-3379. FS Date: 12/4/2013

Concrete U-shaped headwall on WS toe. Note erosion scarp around headwall.

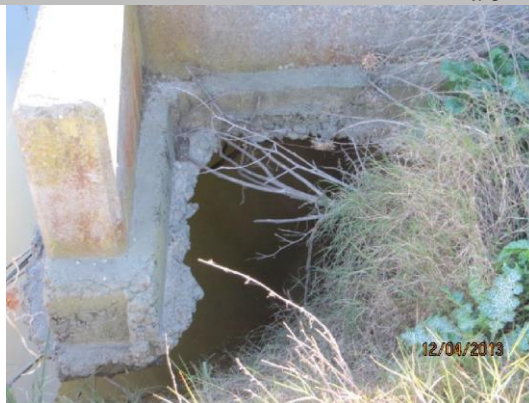
Photo 2 of 2 : UCIP_SP_2016_25007_45089.jpg

Headwall undermined on WS toe.

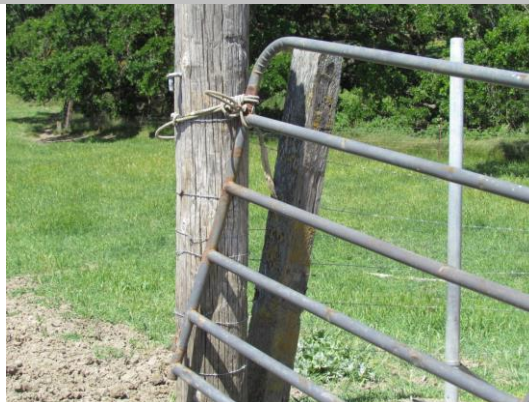
Photo 1 of 1 : SP_2016_RD2104_249_73_20160223_00012.jpg

LM Start	5.29	Rating **	U	Issue No.	73
LM End	5.29	Issue Type +	Ma	Location *	CR
Category	Earthen Levee			GPS Latitude/Longitude	
				Start	End
Item	Repair Gates			38.323281 °	38.323281 °
				-121.751272 °	-121.751272 °
DWR ID	DWR_RD2104_01_s_2014_73				
Comment Code					
Inspector Comment

Repair this gate at levee mile 5.72.

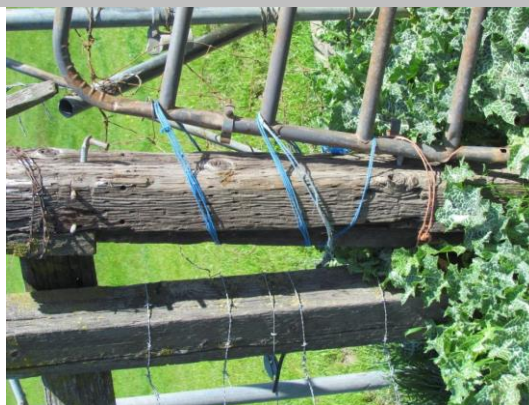
Photo 1 of 1 : SP_2016_RD2104_249_77_20160509_00047.jpg

LM Start	5.51	Rating **	U	Issue No.	77
LM End	5.51	Issue Type +	Ma	Location *	CR
Category	Earthen Levee			GPS Latitude/Longitude	
				Start	End
Item	Repair Gates			38.325048 °	38.325048 °
				-121.754357 °	-121.754357 °
DWR ID	DWR_RD2104_01_s_2014_77				
Comment Code					
Inspector Comment					
Replace this damaged gate crossing the levee crown roadway.

RD 2104 levee mile 5.51 gate crossing crown roadway damaged.

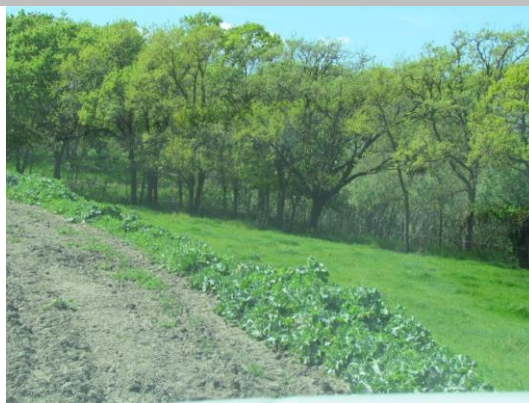
Photo 1 of 1 : SP_2016_RD2104_249_21_20160519_00062.jpg

LM Start	5.52	Rating **	U	Issue No.	21
LM End	6.13	Issue Type +	Ma	Location *	WS
Category	Earthen Levee			GPS Latitude/Longitude	
				Start	End
Item	Vegetation			38.325082 °	38.318590 °
				-121.754645 °	-121.758210 °
DWR ID	DWR_RD2104_01_s_2016_21				
Comment Code					
V1 : Control annual grass and weeds on the levee slopes and easements.					
Inspector Comment

RD 2104 Looking downstream from levee mile 5.52 waterside shoulder tall unwanted milkweed thistle present.
